# PROPERTY INSPECTION REPORT

Precision Inspection Group

123 Main Street

Date of Inspection: 2/13/2026

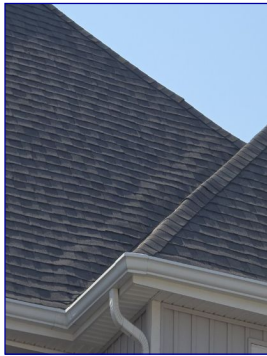
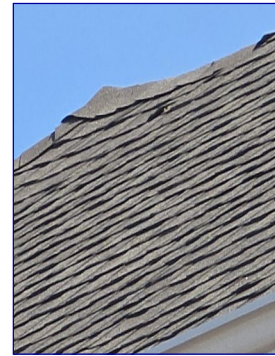
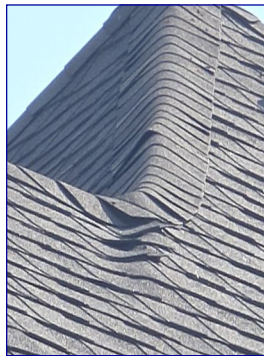
Page 7 Item: 1	Roof View	<ul style="list-style-type: none"> <li>• The asphalt roof shingles appear to be raised in multiple areas. Raised shingles may be more vulnerable to wind damage and water intrusion. Evaluation and repair by a qualified roofing contractor is recommended.</li> <li>• A damaged asphalt shingle was observed at the rear of the home. Damaged shingles can allow moisture intrusion and should be repaired or replaced by a qualified roofing contractor.</li> </ul>
----------------	-----------	--

Possible raised shingles

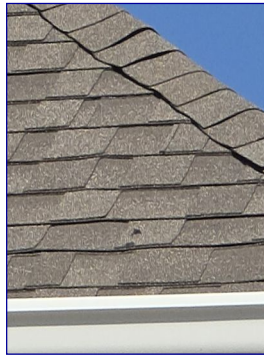
Damaged asphalt shingle on southeast corner of roof

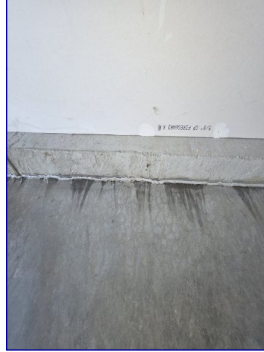
Page 12 Item: 9	Floor	<ul style="list-style-type: none"> <li>Evidence of water intrusion was observed in the garage. Further evaluation and corrective action by a qualified contractor is recommended to determine the source and prevent future moisture damage.</li> </ul>
-----------------	-------	---

Signs of water intrusion on garage floor

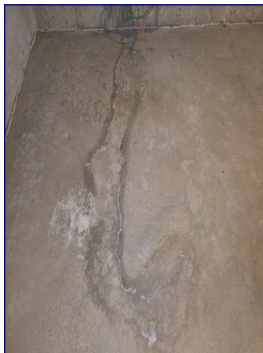
Page 18 Item: 2	Basement Floor	<ul style="list-style-type: none"> <li>There were one or more large settling cracks in the basement slab. Recommend a licensed contractor evaluation and repair.</li> <li>Mineral deposits consistent with efflorescence were present on the concrete basement floor. This condition suggests moisture migration through the slab. Further evaluation and corrective measures to address moisture sources are recommended.</li> </ul>
-----------------	----------------	---

Efflorescence on concrete basement floor

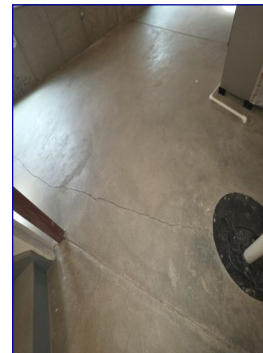
Basement concrete cracked floor

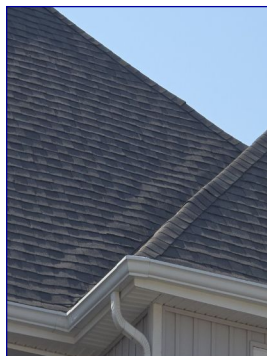
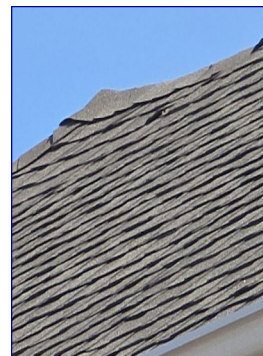
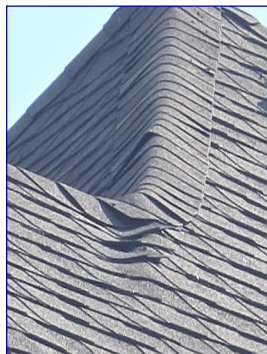
- The asphalt roof shingles appear to be raised in multiple areas. Raised shingles may be more vulnerable to wind damage and water intrusion. Evaluation and repair by a qualified roofing contractor is recommended.
- A damaged asphalt shingle was observed at the rear of the home. Damaged shingles can allow moisture intrusion and should be repaired or replaced by a qualified roofing contractor.

Possible raised shingles

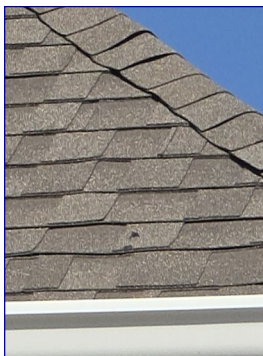
Damaged asphalt shingle on southeast corner of roof

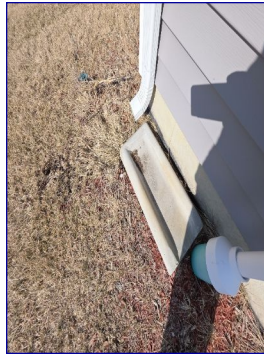
- The gutter downspouts don't direct water far enough away from the house. Recommend adding downspout extensions (5-6' extensions recommended) to discharge away from the home.

Southwest gutter downspout splash guard not in place

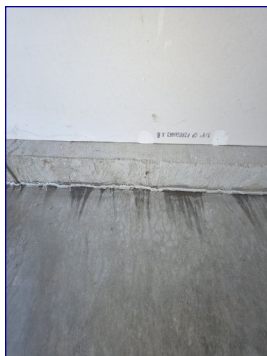
• Evidence of water intrusion was observed in the garage. Further evaluation and corrective action by a qualified contractor is recommended to determine the source and prevent future moisture damage.

Signs of water intrusion on garage floor

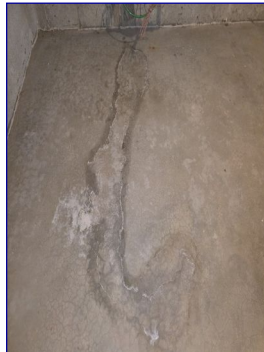
- There were one or more large settling cracks in the basement slab. Recommend a licensed contractor evaluation and repair.
- Mineral deposits consistent with efflorescence were present on the concrete basement floor. This condition suggests moisture migration through the slab. Further evaluation and corrective measures to address moisture sources are recommended.

Efflorescence on concrete basement floor

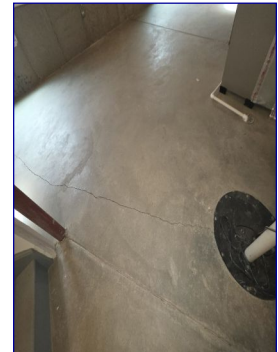
Basement concrete cracked floor

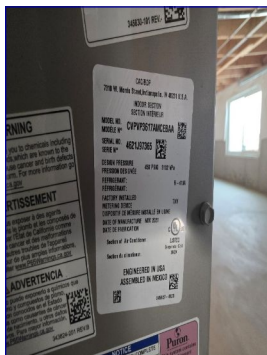
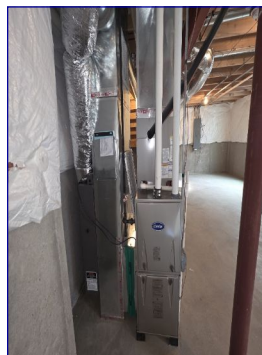
- Seasonal dust buildup was observed on the furnace cabinet and accessible components. Preventative maintenance and cleaning are advised. A licensed HVAC contractor should evaluate and service the unit prior to closing to verify proper function and system performance.
