Sewer Scope Report

John Doe
123 Main Street,
Somewhere, IL 60000

2/14/2026

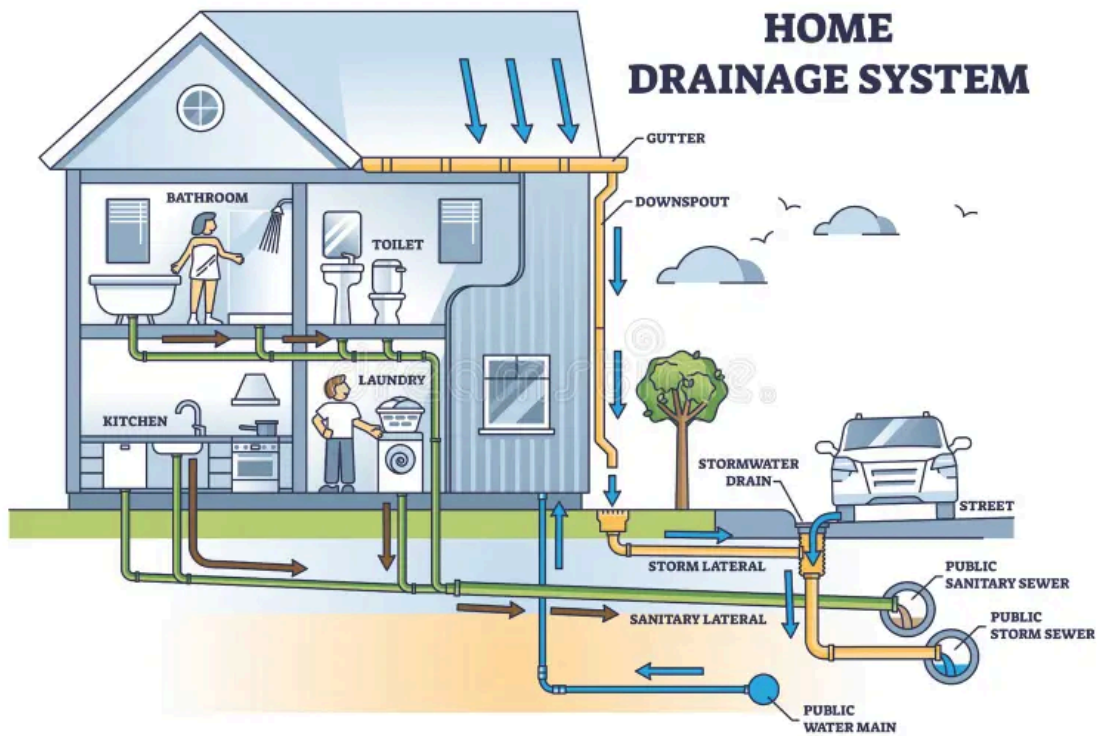
Cast iron

Total 53 feet

No issues observed

- No issues or defects were observed in the sanitary piping during the inspection.
