# PROPERTY INSPECTION REPORT

Precision Inspection Group

123 Main Street

Date of Inspection: 2/13/2026

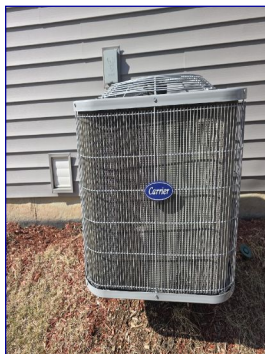
2021 Carrier

- The air conditioner was not operated due to the outside temperature. The unit should not be operated when the outside temperature is less than 60 degrees. Recommend a licensed HVAC contractor clean and check the **BTU** performance before using.

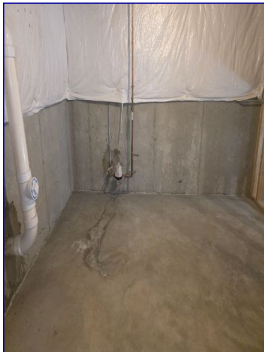
Basement

- There were one or more large settling cracks in the basement slab. Recommend a licensed contractor evaluation and repair.
- Mineral deposits consistent with efflorescence were present on the concrete basement floor. This condition suggests moisture migration through the slab. Further evaluation and corrective measures to address moisture sources are recommended.
